**Flood Control Project Maintenance
Levee Inspections**
LMA District Cover Sheet
Spring 2010 Levee Inspection Results

Reclamation District No. 0501 Ryer Island

Levee Inspection Report By Mile - Spring 2010

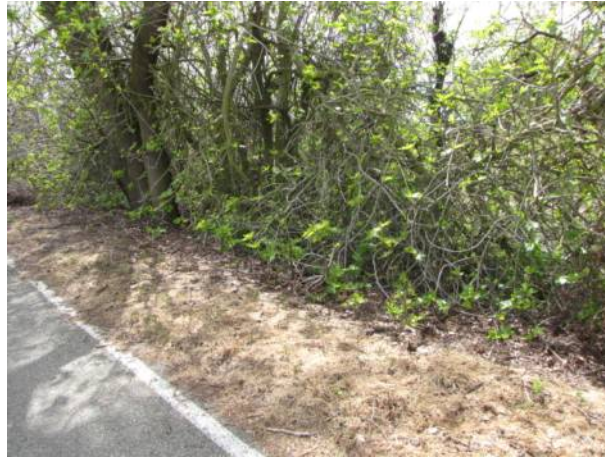
Levee Mile Report Line	4
Start Levee Mile	0.05
End Levee Mile	0.06
Location	Land Side
Category	Earthen Levee
Item	Trim / Thin rees

photo show wild growth of fog trees on shoulder and slope of levee, not able to see the leve slope at all.

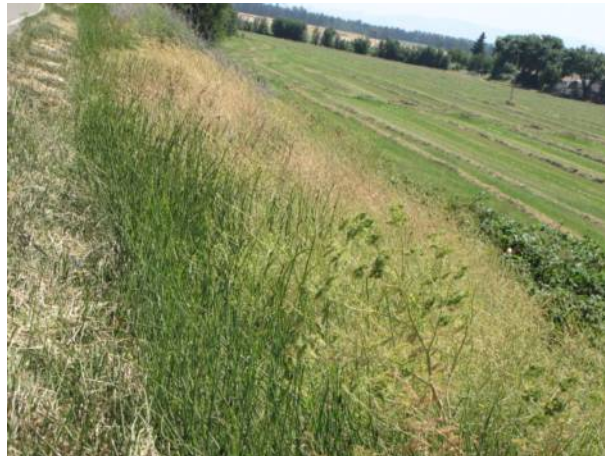
Levee Mile Report Line	18
Start Levee Mile	0.73
End Levee Mile	1.17
Location	Land Side
Category	Earthen Levee
Item	Vegetation

This photo shows where the berry vines has covered the slope from shoulder to toe of levee section. Levee mile 0.73 to levee mile 0.79

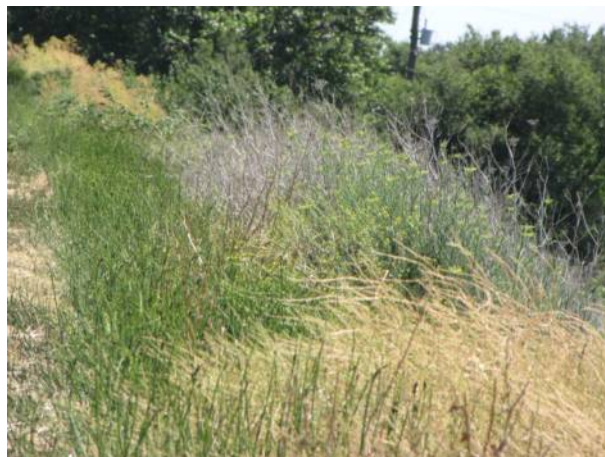
Levee Mile Report Line	18
Start Levee Mile	0.73
End Levee Mile	1.17
Location	Land Side
Category	Earthen Levee
Item	Vegetation

Land side looking down stream berry vines has claimed the levee slope.

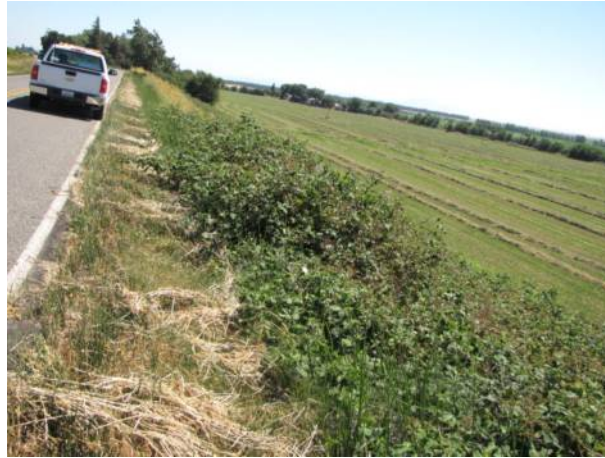
Levee Mile Report Line	18
Start Levee Mile	0.73
End Levee Mile	1.17
Location	Land Side
Category	Earthen Levee
Item	Vegetation

Berry vines continue out of control along the levee section from sholder to toe of levee section. Standing at levee mile 0.79 looking down stream.

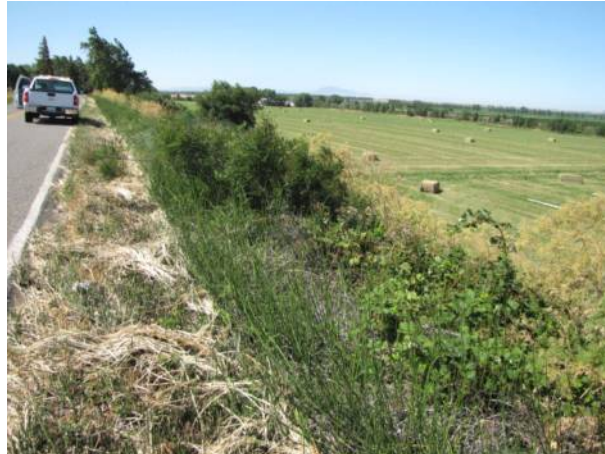
Levee Mile Report Line	19
Start Levee Mile	0.75
End Levee Mile	0.94
Location	Land Side
Category	Earthen Levee
Item	Vegetation

The berries here completely blocks the view of the levee section. Standing at levee mile 0.75 looking downstream to levee mile 0.94.

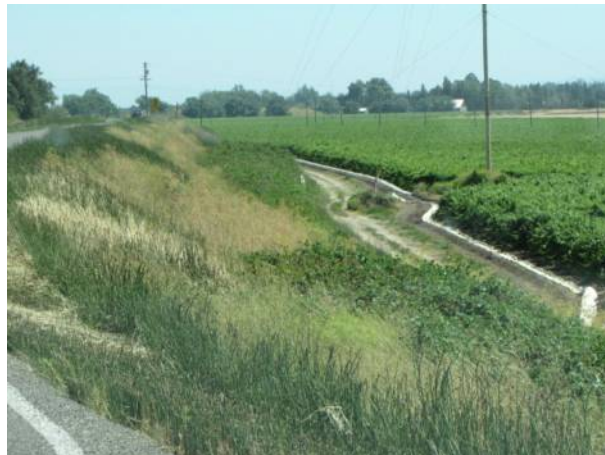
Levee Mile Report Line	24
Start Levee Mile	1.55
End Levee Mile	1.74
Location	Land Side
Category	Earthen Levee
Item	Vegetation

Levee mile 1.55 looking downstream landside slope is covered with wild berries.

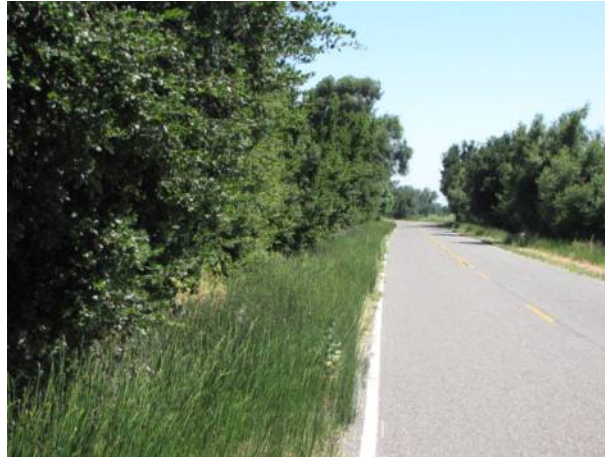
Levee Mile Report Line	38
Start Levee Mile	3.34
End Levee Mile	3.36
Location	Land Side
Category	Earthen Levee
Item	Trim / Thin rees

Wild growth of trees on the landward shoulder and slope on levee. Standing at levee mile 3.34 looking downstream to levee mile 3.36.

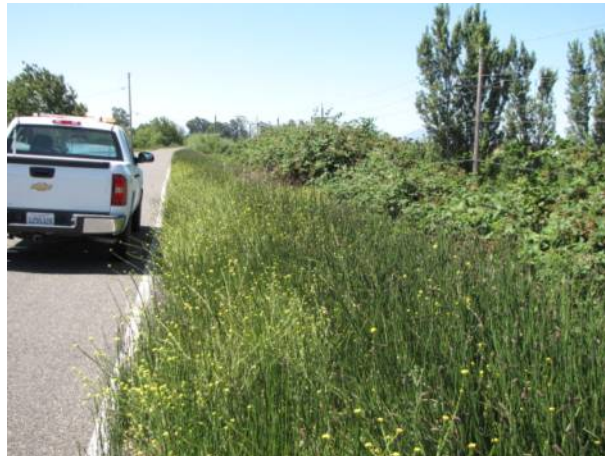
Levee Mile Report Line	47
Start Levee Mile	3.80
End Levee Mile	4.14
Location	Land Side
Category	Earthen Levee
Item	Vegetation

This section here shows that the berry vines are taller than the cab of the truck, you can't see the slope or toe because of the wild growth.

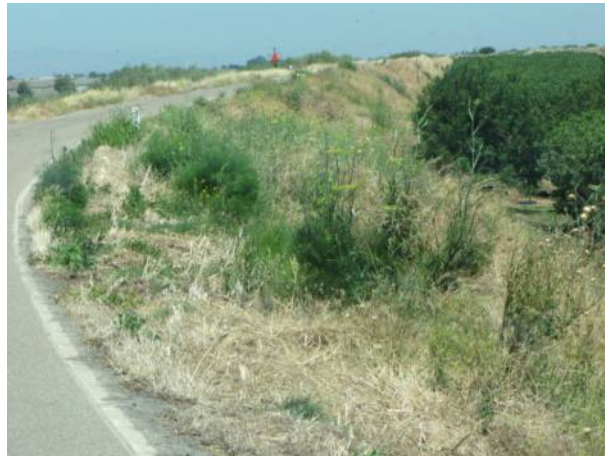
Levee Mile Report Line	13
Start Levee Mile	1.30
End Levee Mile	1.40
Location	Crown
Category	Earthen Levee
Item	Cracking
Levee mile 2.46 looking downstream on land side weeds needs to be controlled, slopes can not be seen. This growth proceeds downstream to levee mile 3.37.	
phillips_s_20100630_116.jpg

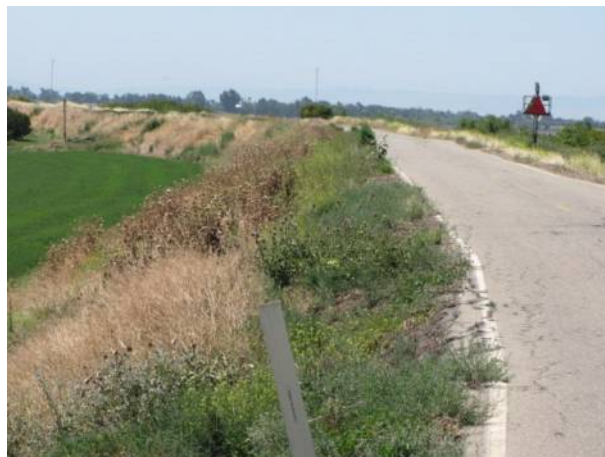
Levee Mile Report Line	13
Start Levee Mile	1.30
End Levee Mile	1.40
Location	Crown
Category	Earthen Levee
Item	Cracking
Standing at levee mile 3.37 land side looking back upstream to levee mile 2.46. Can't see the slope for wild growth.	
phillips_s_20100630_117.jpg

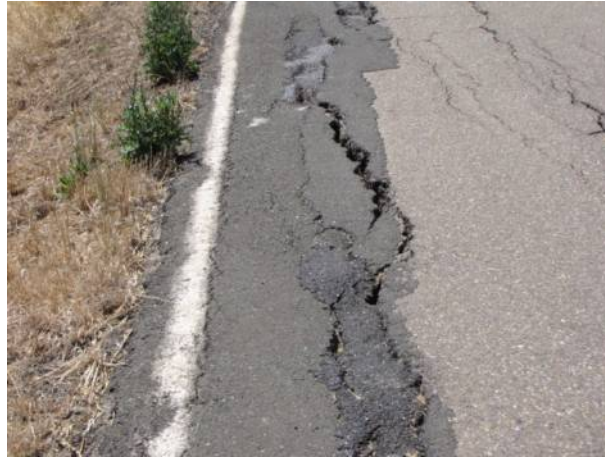
Levee Mile Report Line	14
Start Levee Mile	1.48
End Levee Mile	1.71
Location	Crown
Category	Earthen Levee
Item	Cracking

Looking at cracking on roadway, this shot is representation of many cracks along the roadway in this unit. This levee has shown cracks for many years now

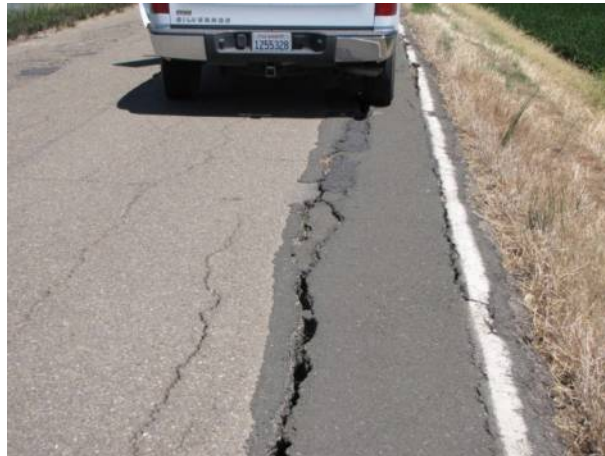
Levee Mile Report Line	14
Start Levee Mile	1.48
End Levee Mile	1.71
Location	Crown
Category	Earthen Levee
Item	Cracking

Cracking continues.

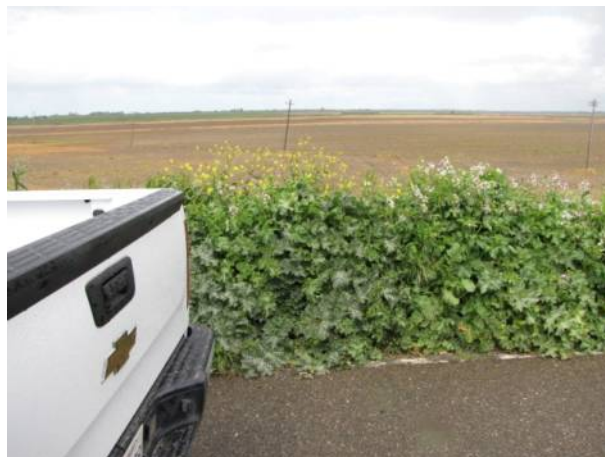
Levee Mile Report Line	18
Start Levee Mile	2.46
End Levee Mile	3.37
Location	Land Side
Category	Earthen Levee
Item	Vegetation

The weeds on the L/S slope are taller than the vehicle. These weeds are on the slope and shoulder.

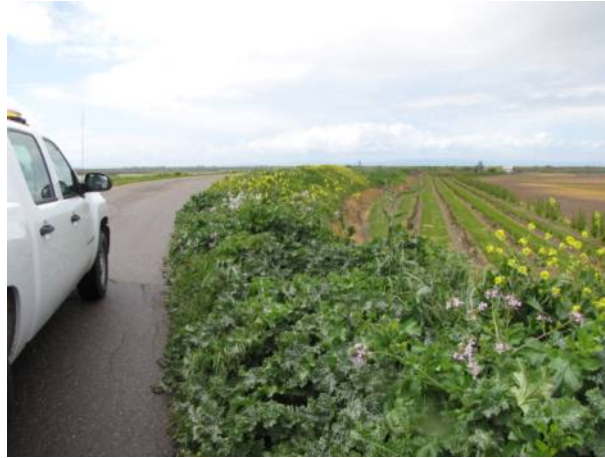
This shot actually shows the extent of growth on the slopes. I'm facing down stream. The weeds are the same through this unit.

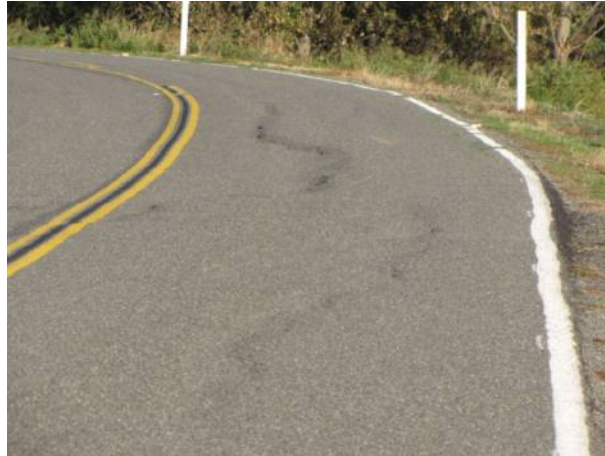
Levee Mile Report Line	5
Start Levee Mile	1.74
End Levee Mile	1.75
Location	Crown
Category	Earthen Levee
Item	Cracking
Cracks in crown roadway, the crown appears to be sinking in the middle	
phillips_s_20100316_011.jpg

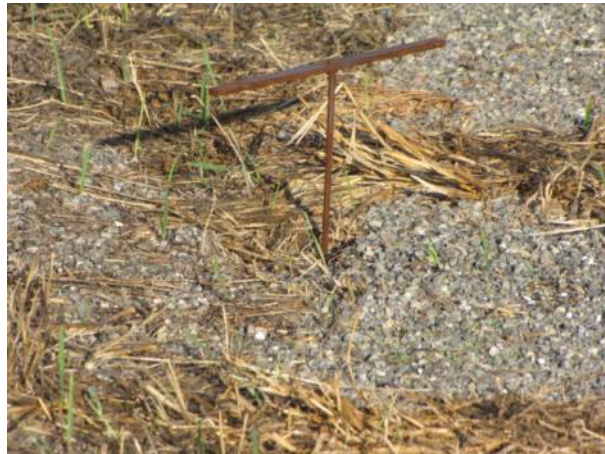
Levee Mile Report Line	5
Start Levee Mile	1.74
End Levee Mile	1.75
Location	Crown
Category	Earthen Levee
Item	Cracking
This probe is stuck in the crack along the shoulder land ward, its in the crown 3-4 foot no resistance.	
phillips_s_20100316_012.jpg

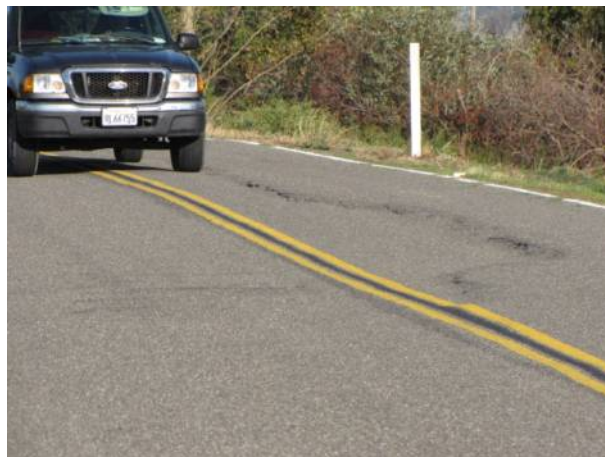
Levee Mile Report Line	5
Start Levee Mile	1.74
End Levee Mile	1.75
Location	Crown
Category	Earthen Levee
Item	Cracking
Depression here has a difference in elevation 1-2-inches if nor more.	
phillips_s_20100316_013.jpg

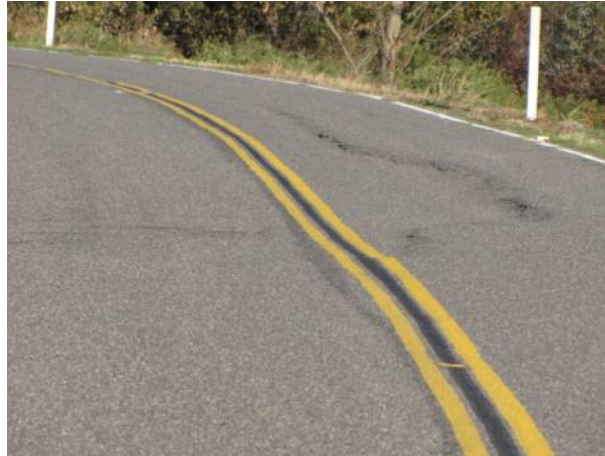
Levee Mile Report Line	5
Start Levee Mile	1.74
End Levee Mile	1.75
Location	Crown
Category	Earthen Levee
Item	Cracking

Shown here with out the vehicle in view.

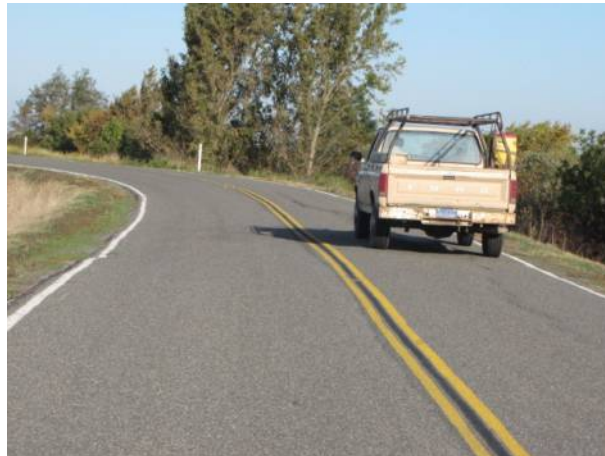
Levee Mile Report Line	5
Start Levee Mile	1.74
End Levee Mile	1.75
Location	Crown
Category	Earthen Levee
Item	Cracking

Another view within same area. The County has placed caution signs within damaged area to slow the traffic down.

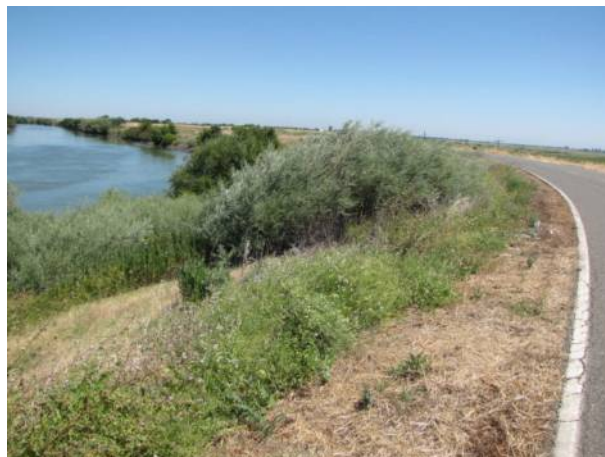
Levee Mile Report Line	7
Start Levee Mile	2.23
End Levee Mile	2.27
Location	Water Side
Category	Earthen Levee
Item	Trim / Thin rees

Levee mile 2.23 looking downstream from waterside.

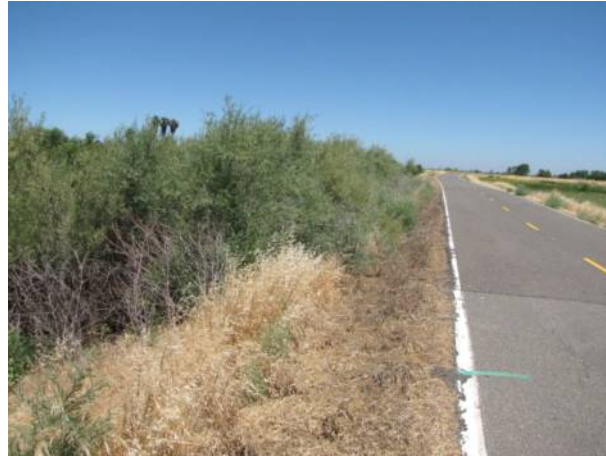
Levee Mile Report Line	7
Start Levee Mile	2.23
End Levee Mile	2.27
Location	Water Side
Category	Earthen Levee
Item	Trim / Thin rees
Looking downstream at 2.27 water side willows taken over slope snotinuing sownstream.	
phillips_s_20100630_121.jpg

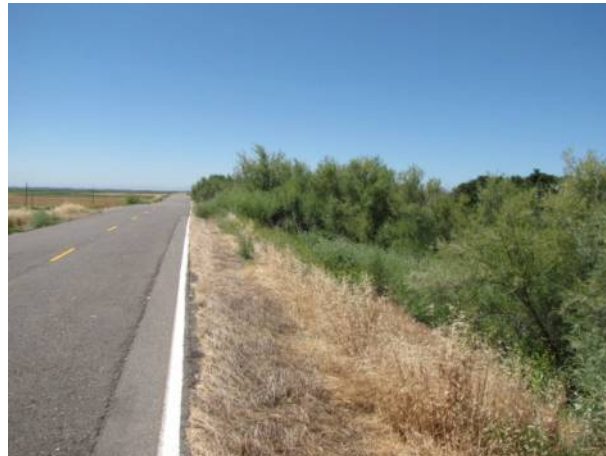
Levee Mile Report Line	10
Start Levee Mile	2.65
End Levee Mile	2.77
Location	Water Side
Category	Earthen Levee
Item	Trim / Thin rees
2.65 looking upstream from downstream end waterside.	
phillips_s_20100630_122.jpg

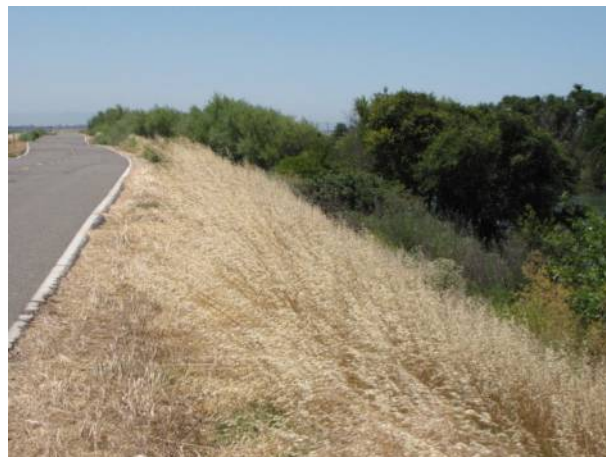
Levee Mile Report Line	10
Start Levee Mile	2.65
End Levee Mile	2.77
Location	Water Side
Category	Earthen Levee
Item	Trim / Thin rees
Looking upstream from levee mile 2.77.	
phillips_s_20100630_123.jpg

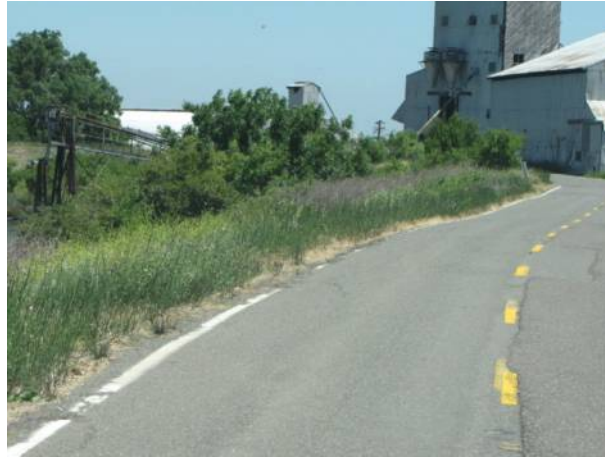
Looking downstream form Levee mile 3.52 wild growth has overtaken slope on waterside.

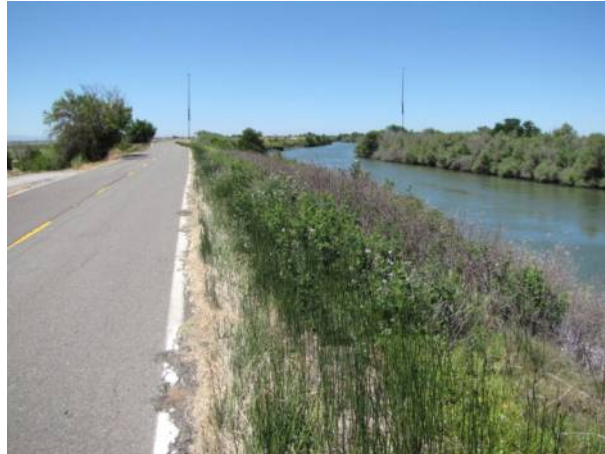
Levee Mile Report Line	12
Start Levee Mile	3.52
End Levee Mile	3.55
Location	Water Side
Category	Earthen Levee
Item	Trim / Thin rees

Levee mile 3.52 standing on waterside looking upstream wild growth.

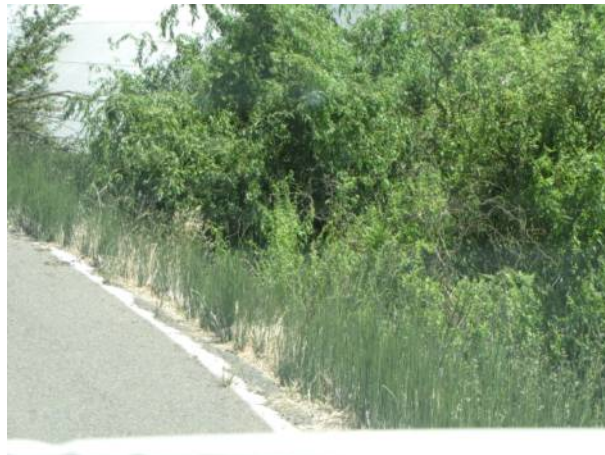
Levee Mile Report Line	12
Start Levee Mile	3.52
End Levee Mile	3.55
Location	Water Side
Category	Earthen Levee
Item	Trim / Thin rees

Levee mile 3.55 land side tree growth on slope, you can't see the slope for wild growth. These trees has not been trimmed.

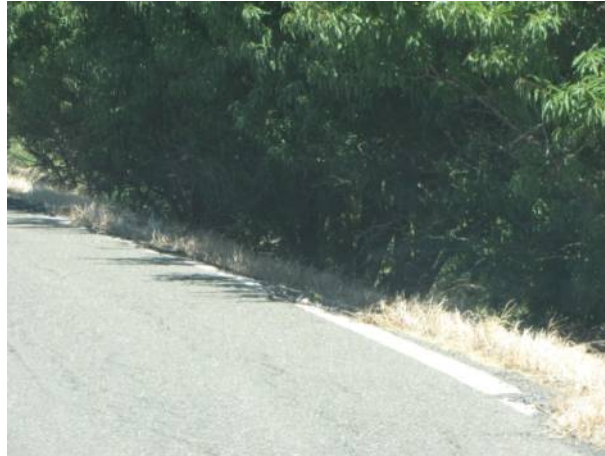
Levee Mile Report Line	14
Start Levee Mile	3.69
End Levee Mile	3.70
Location	Land Side
Category	Earthen Levee
Item	Trim / Thin rees
Levee mile 3.69 tree growth has blocked view of levee on the land side.	
phillips_s_20100630_127.jpg

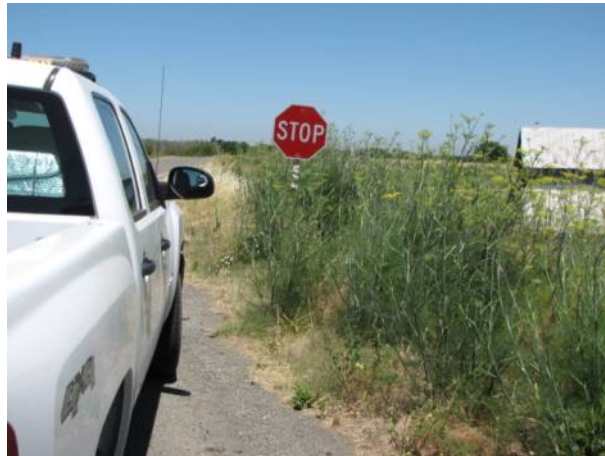
Levee Mile Report Line	14
Start Levee Mile	3.69
End Levee Mile	3.70
Location	Land Side
Category	Earthen Levee
Item	Trim / Thin rees
Looking downstream from 3.70 tall growth continues down stream from this point.	
phillips_s_20100630_128.jpg

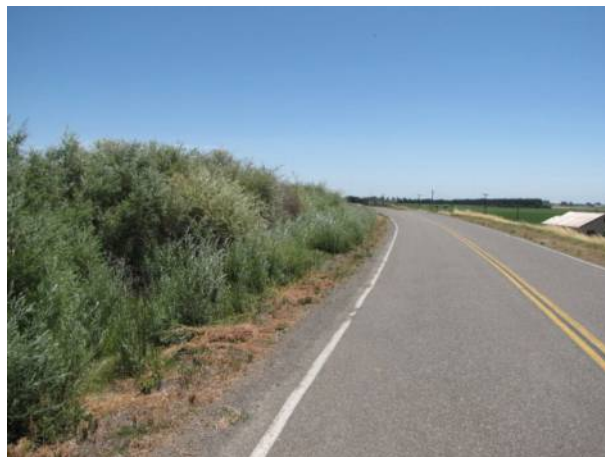
Levee Mile Report Line	24
Start Levee Mile	6.43
End Levee Mile	6.52
Location	Water Side
Category	Earthen Levee
Item	Trim / Thin rees
Levee mile 6.43 water side the wild growth blocks view of water ward slope, looking downstream. You can't see the levee section for the wild growth.	
phillips_s_20100630_129.jpg

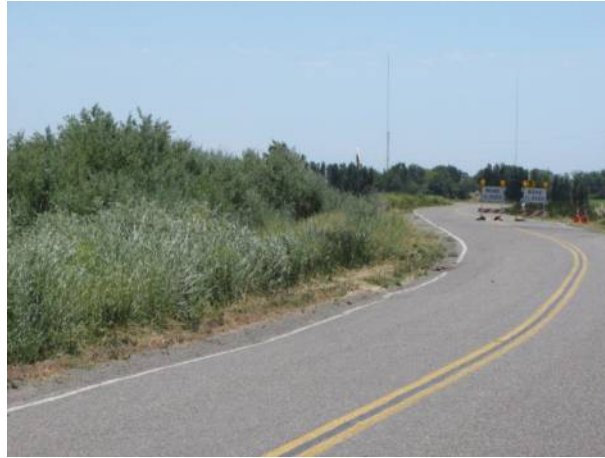
Wild growth continues downstream, levee section blocked by growth.

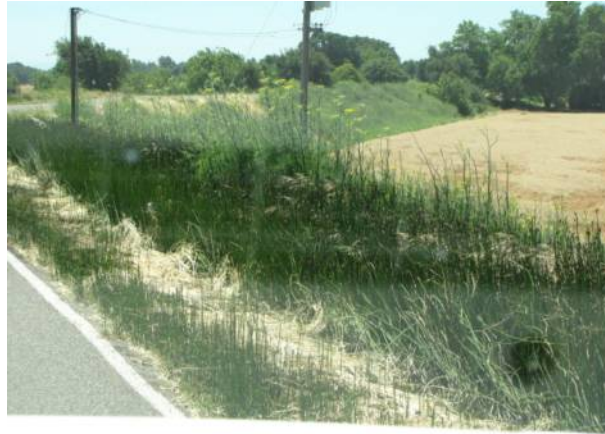
Looking downstream land side wild growth laking over the slope continuing onward downstream to levee mile 1.15

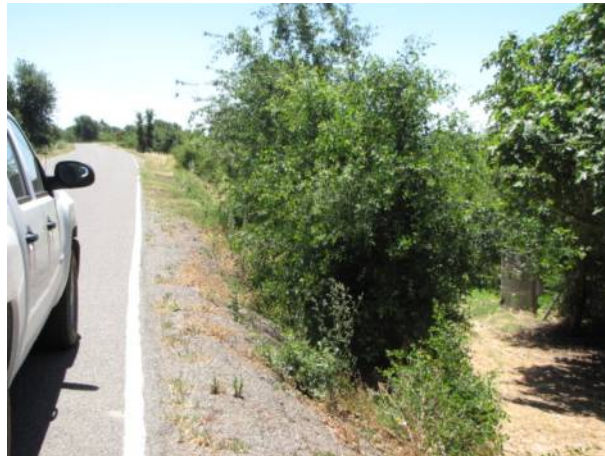
Levee Mile Report Line	12
Start Levee Mile	1.84
End Levee Mile	1.87
Location	Land Side
Category	Earthen Levee
Item	Trim / Thin rees

Levee mile 1.84 looking downstream landside oak tree growth cover slope from hinge point to toe as seen in this photo.

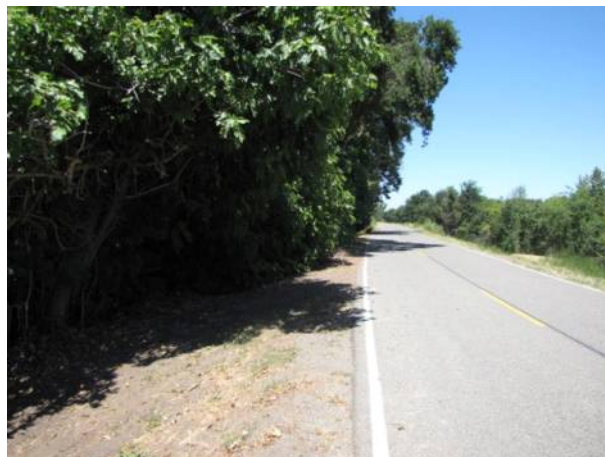
Levee Mile Report Line	12
Start Levee Mile	1.84
End Levee Mile	1.87
Location	Land Side
Category	Earthen Levee
Item	Trim / Thin rees

Looking back upstream from landside the fig trees has not been maintained, they block the shoulder and slope of the levee section as well as hanging over the levee.

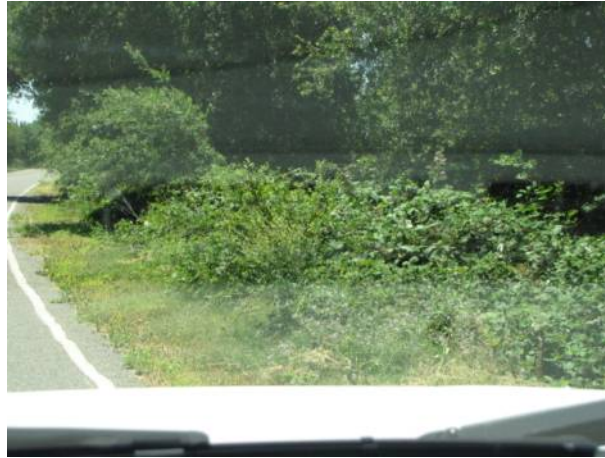
Levee mile 2.11 looking downstream berry vines completely covering levee section.

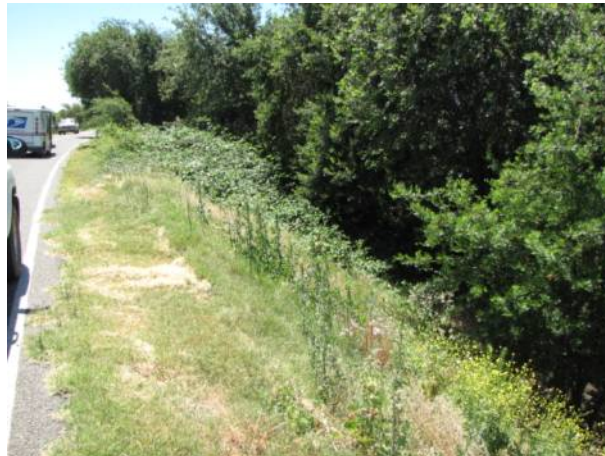
Levee Mile Report Line	14
Start Levee Mile	2.11
End Levee Mile	2.20
Location	Land Side
Category	Earthen Levee
Item	Vegetation

Wild growth of berries continues. Another shot showing growth levee mile 2.11 looking towards 2.20 landward.

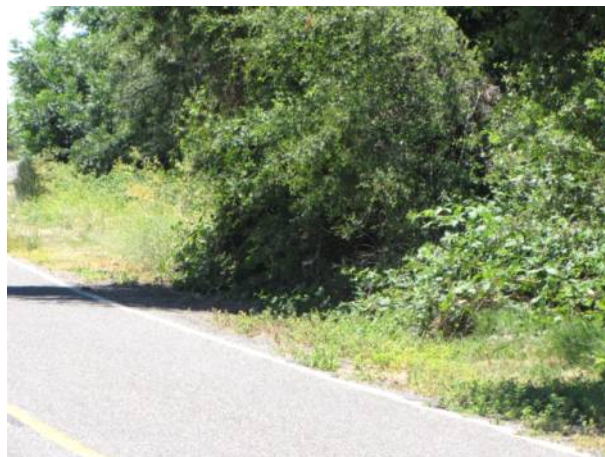
Levee Mile Report Line	14
Start Levee Mile	2.11
End Levee Mile	2.20
Location	Land Side
Category	Earthen Levee
Item	Vegetation

Looking downstream.

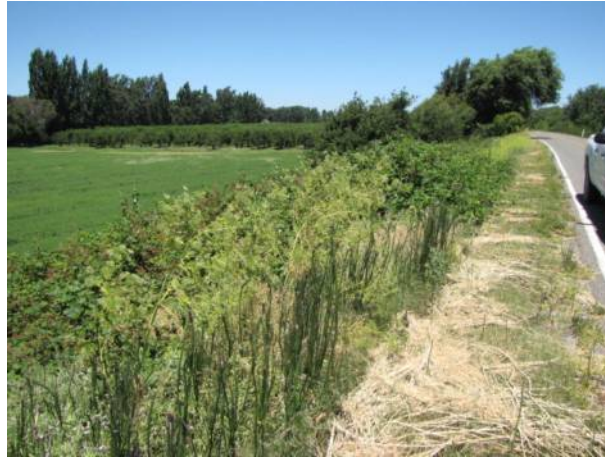
Looking upstream at wild berries from shoulder to toe.
